Quantum Building Inspections

Property Inspection Report

345 Perfect Rd., Spokane, WA 99201
Inspection prepared for: Happy Homebuyer
Date of Inspection: 9/1/2018 Time: 9:00 AM
Age of Home: 2000 Size: 1658 sq ft (approx)
Weather: Partly Cloudy, 50 degrees

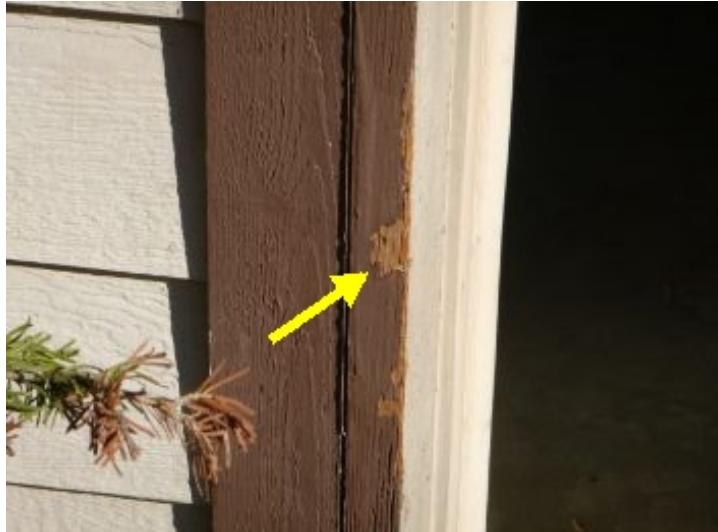
2.1. Areas of the trim had chipping and/or peeling paint or stain. If not corrected, deterioration of the bare wood could occur. Some loan programs, such as FHA and VA require these conditions to be repaired prior to closing. Proper repair and refinishing is needed.

Peeling paint on trim.

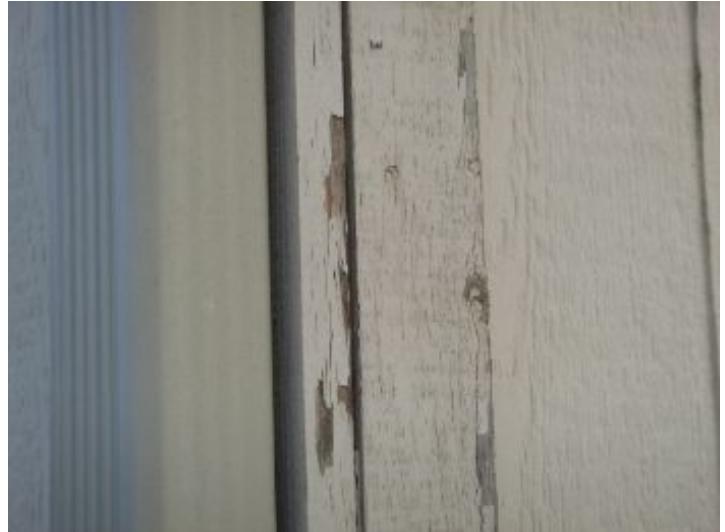
More peeling paint.

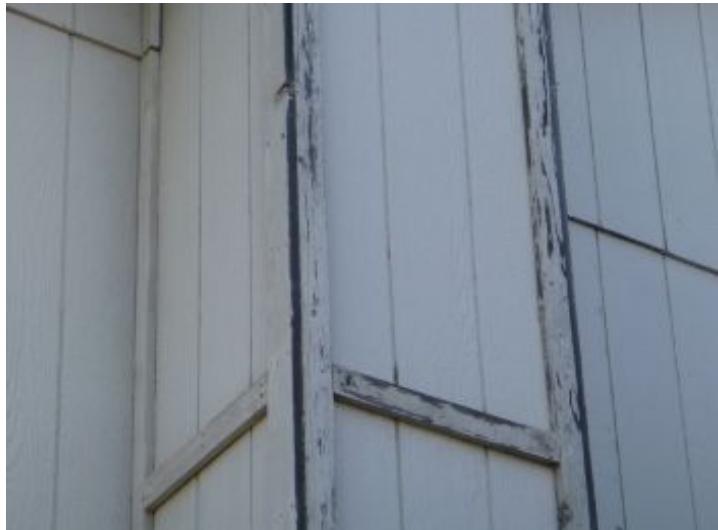
9.1. Frame Chimney(s): The painted finish on the wood framed chimney was failing. Recommend proper re-finishing of the finish materials to extend their life.

Peeling paint on chimney trim.

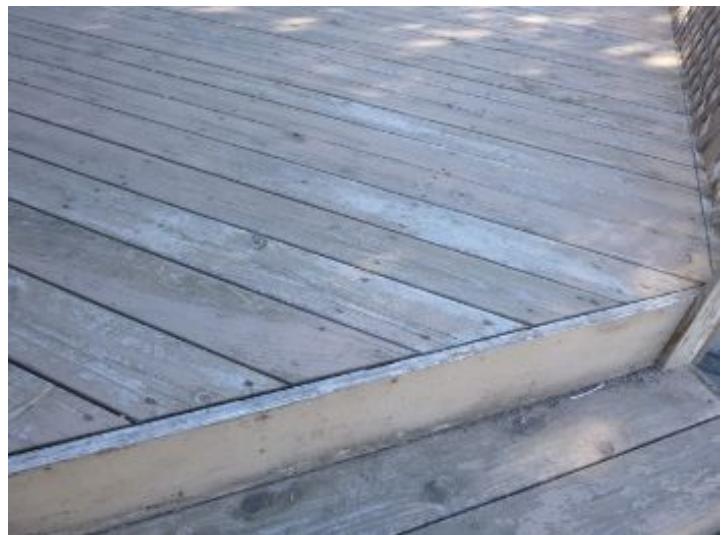
5.1. One or more areas of failing paint or stain were noted. If not corrected, deterioration of the bare wood could occur. Proper refinishing and caulking is recommended.

Deck needs paint or stain.

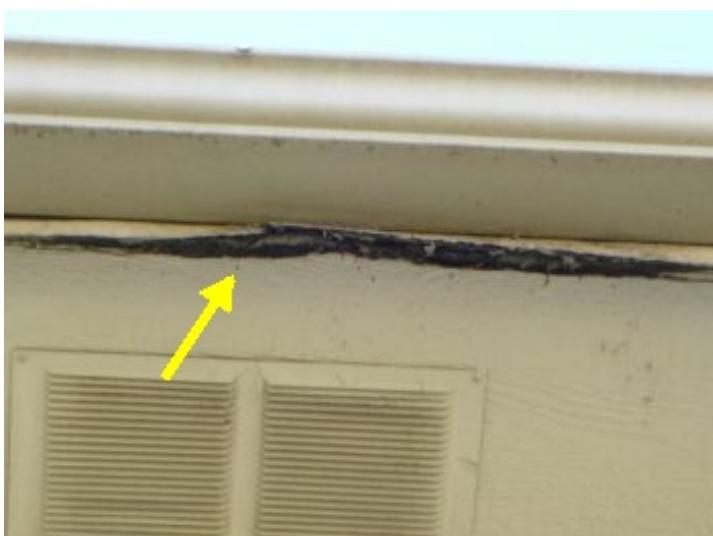
3.1. Water damage was noted at the bottom edges of fascia material around the home. The fascia material is made of composite wood, which is susceptible to water damage and rot as water wicks up into the material from the bottom edge. Sometimes the bottom edge of the fascia can be cleaned up, sealed and painted and in other areas the fascia board may need replacement. A better product to use would be cement fiber board, which is not prone to water damage or rot. Review by a qualified contractor is needed for repair options and cost estimates. This was noted mainly on the back of the home.

Rotted fascia board on back of home.

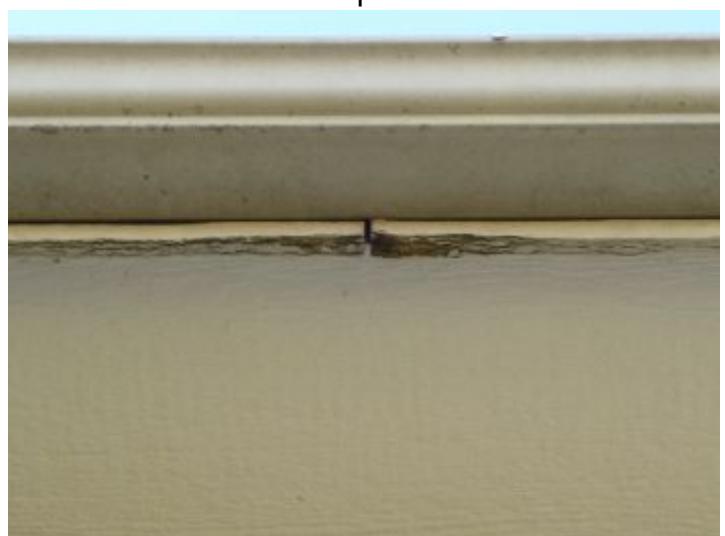
Another area of water damage on fascia board.

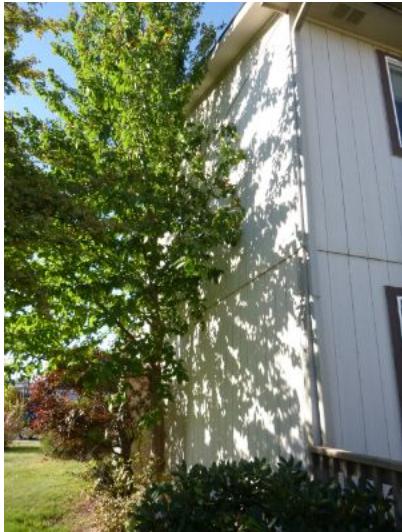
- 9.1. Trees, shrubs and/or vines were overgrown at roof areas and around exterior of home. Recommend cutting these back to maintain at least 8 to 12 inches of clear space between the structure and any vegetation to promote proper air circulation and help prevent damage from stains, moisture and insects.

Cut tree away from siding.

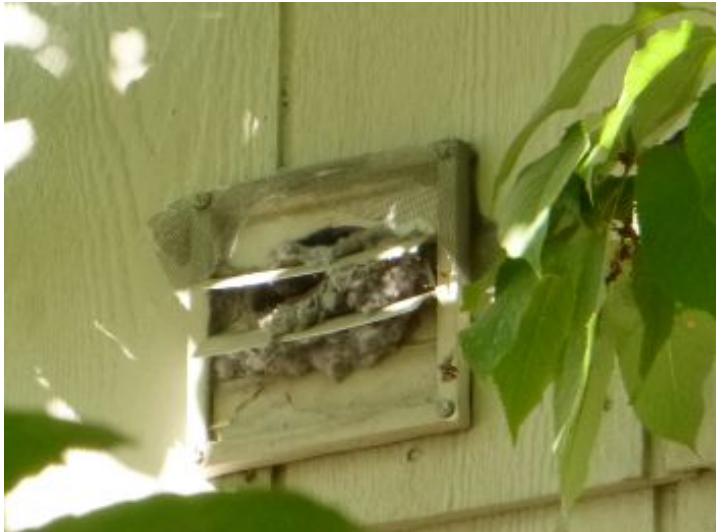
- 10.1. Clothes Dryer Vent, The exterior clothes dryer vent appears to be clogged with lint. This is a fire hazard. Proper correction or replacement is recommended.

Clothes dryer vent filled with lint.

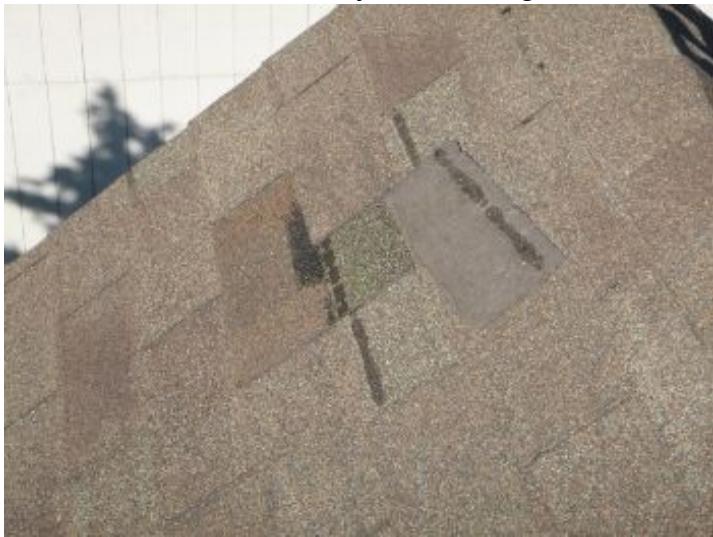
5.2. Asphalt or Fiberglass Shingles: One or more of the roofing shingles had loose and/or missing tabs. This results when the tabs are not sealed properly to the shingles below and get blown off by wind. This may also result in roof leaks or other damage. Repair of the affected shingles is recommended.

Loose/missing shingles on bonus room roof.

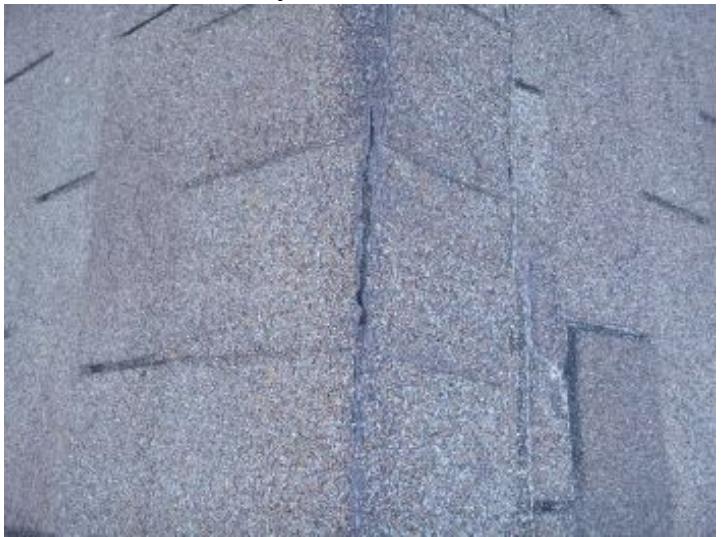
Cracked ridge shingle.

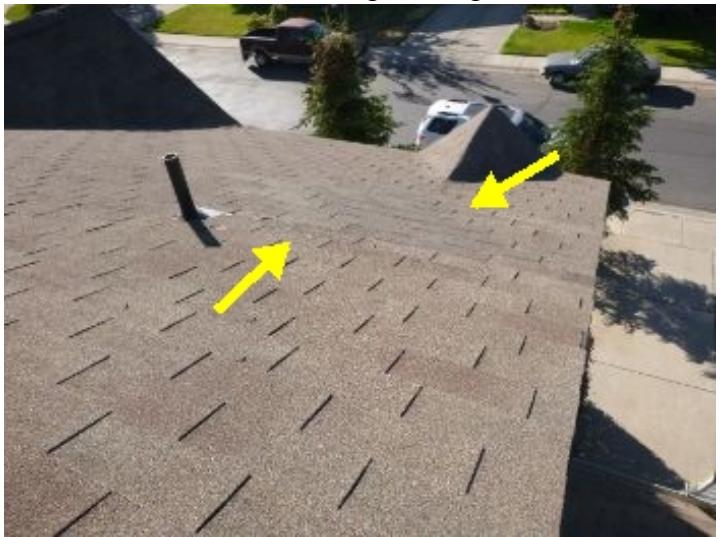
Patched roofing on upper roof surface.

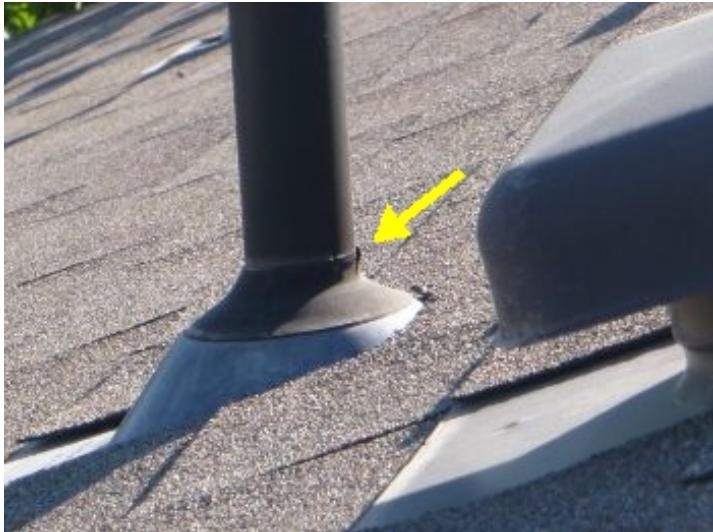
6.1. Aged and cracked rubber seals noted around plumbing pipe vents on the roof. This will result in roof leaks. Review by a qualified contractor is needed for repair options and cost estimates

Cracked rubber boot at plumbing vent pipes.

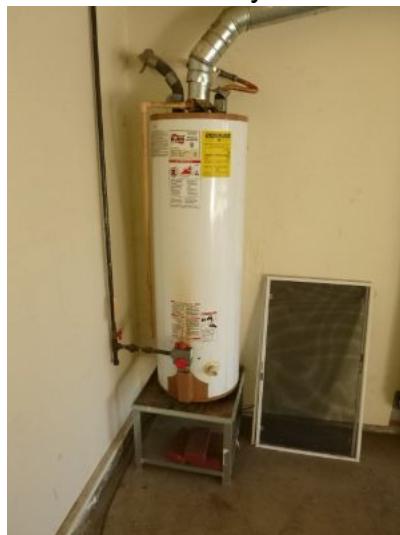
5.1. The water heater was not secured to the wall with earthquake straps. This is a recommended feature for safety and is often required by mortgage institutions. Recommend having earthquake straps installed prior to the appraisal.

Water heater not strapped.

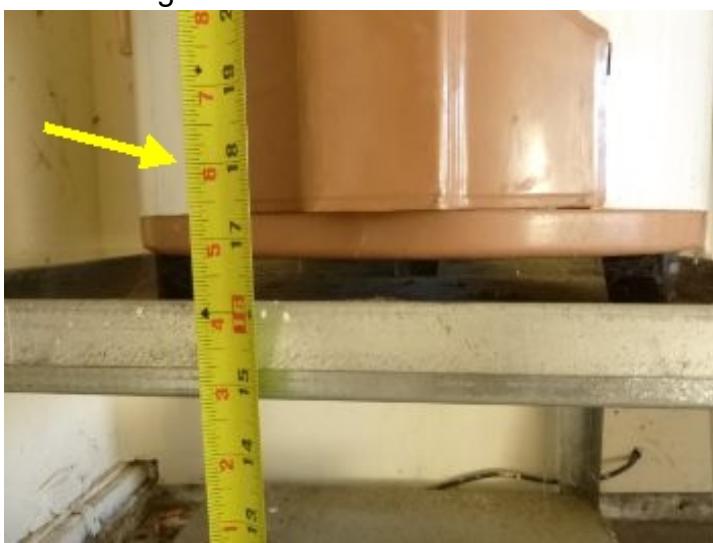
5.3. The water heater is mounted in the garage on a stand that is about 15 in above the garage floor. The requirement is that the water heater be installed 18 in above the floor. Recommend review and correction by a qualified contractor.

Water heater installed below 18 inches above garage floor.

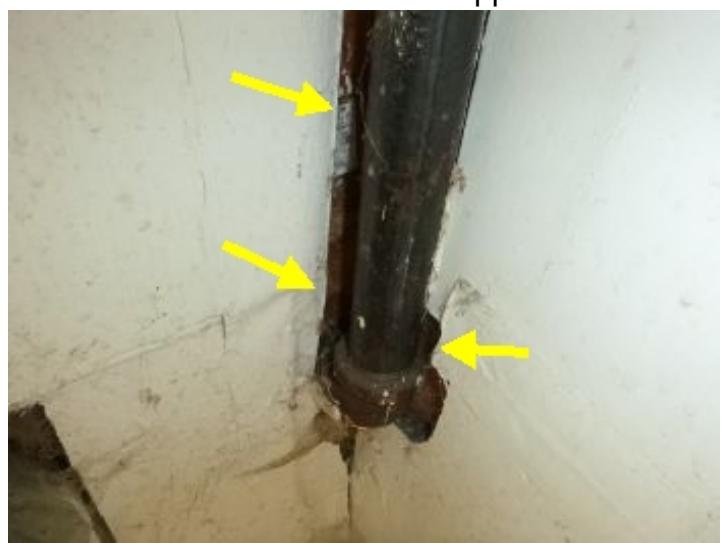
4.2. One or more openings on the walls and/or ceiling were noted that are a breach of the common firewall. This was at the gaps around the gas supply pipe. These openings could allow a garage fire to quickly migrate into main structure. Proper correction is recommended for personal safety.

Gaps in garage drywall need fire caulking.

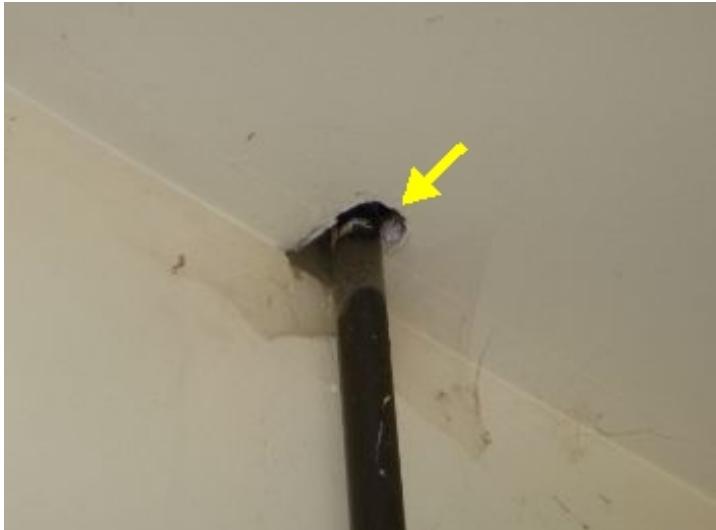
More gaps that need fire caulking.

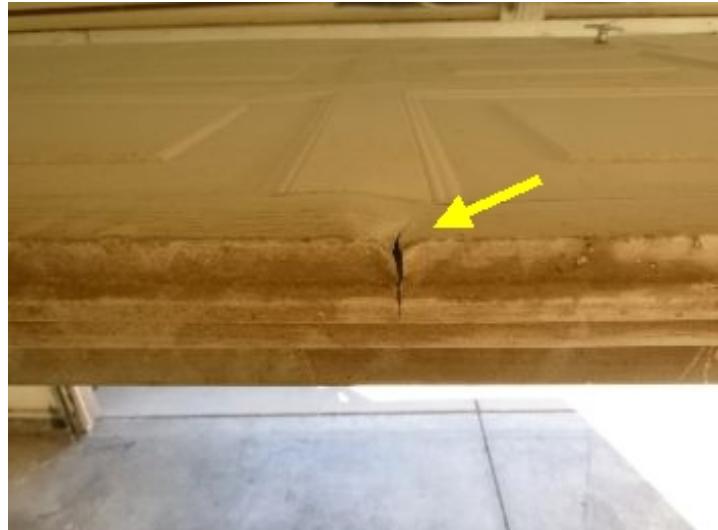
5.1. A crack was noted in the top panel of the overhead garage door. Recommend further review by a qualified contractor for repair options and cost estimates.

Cracked top panel on garage door.

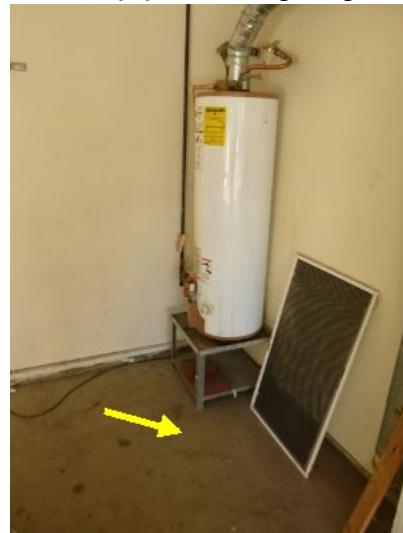
4.1. The water heater is installed in the garage but there is no barrier to prevent a vehicle impact. Recommend further review by a qualified contractor to add an impact barrier for safety.

Add impact barrier in front of water heater in garage.

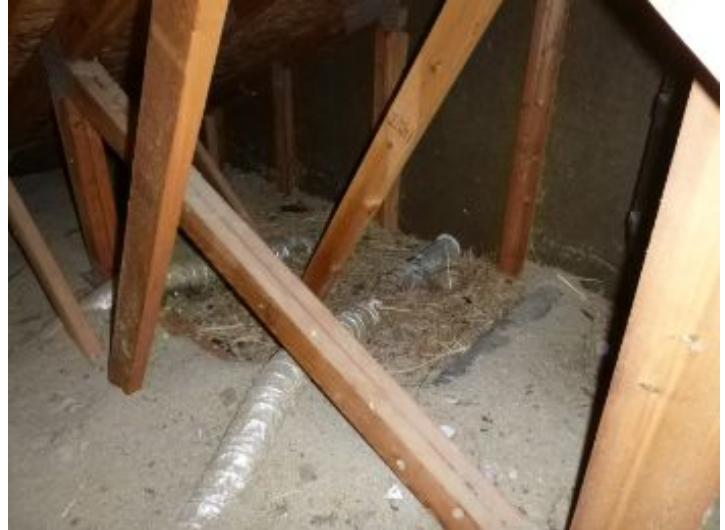
8.2. Animal Habitation, Areas of animal nesting was noted in the attic space at the damaged exhaust fan ducting. It appears that birds are entering the attic at the damaged ducting. Further evaluation and correction by a qualified animal removal service is recommended.

Animal nesting noted in attic.

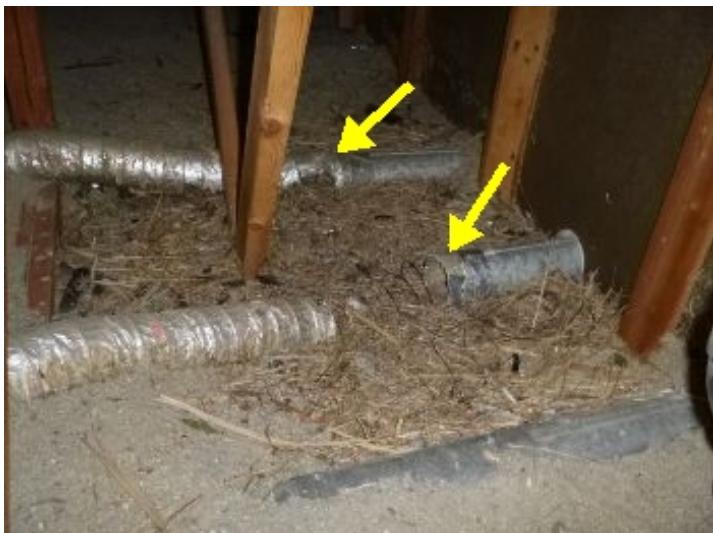
8.1. The bathroom exhaust fan(s) appeared to have a damaged or separated duct and was venting into the attic space. This can trap excessive moisture in the attic space and can promote rotting and mold. This is the likely cause of condensation staining that seeped through to the master bedroom ceiling. Proper correction of the exhaust fan duct by a qualified contractor is needed.

Animals entering through damaged vent ducting.

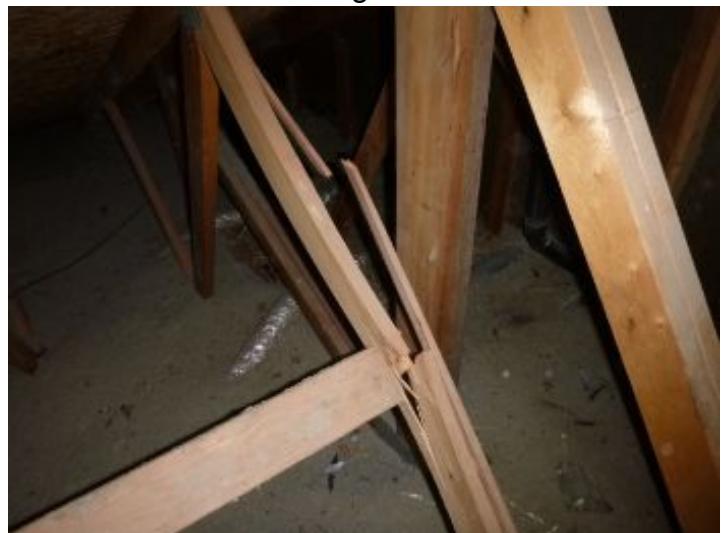
6.1. One or more of the structural framing members were observed to be cracked/damaged. This was noted near the east end of the attic space at a shattered truss web board. Further evaluation and repair by a qualified framing contractor is needed.

Broken truss board needs repair in attic.

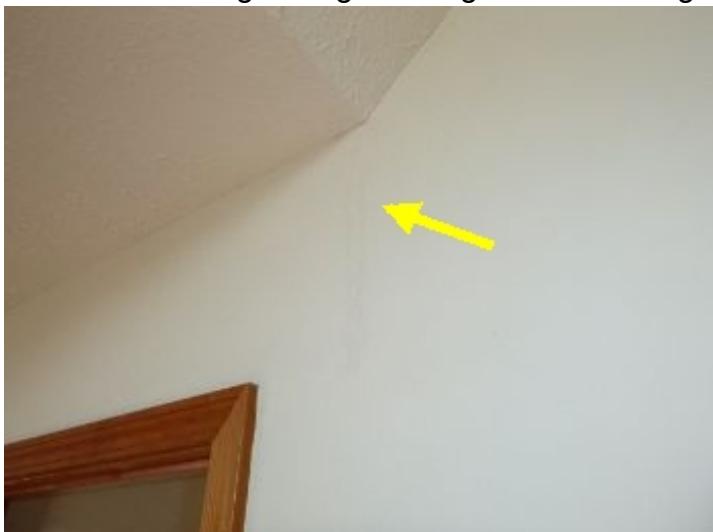
2.2. Staining (apparently from moisture) was observed on the walls in the master bedroom. The staining was DRY when reviewed today. Recommend monitoring of the staining and/or checking with the current owner. Also recommend determination and correction of the source of the staining if still active.

Staining in master bedroom from attic condensation.

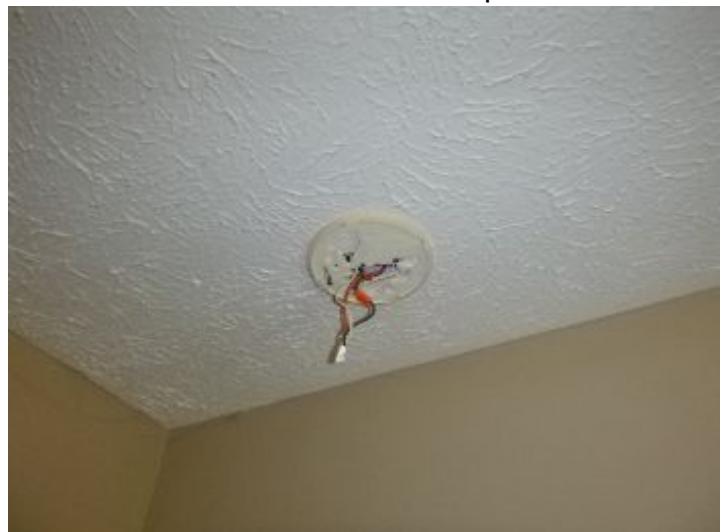
9.2. A smoke alarm was missing from its mounting base in one or more areas of the home.

Missing smoke alarm.

Recommend installing new smoke detector(s) as needed to provide proper protection and alert for fires in the home.

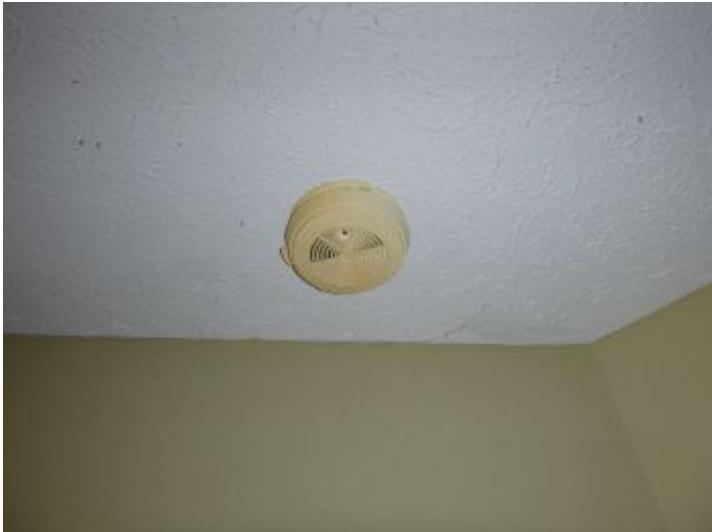
9.1. One or more of the smoke detectors appeared to be older. The sensitivity of a smoke detector tends to diminish with age. It is recommended that smoke detectors be replaced at least every 10 years. Replacement of all older units with new units is recommended for personal safety.

Aged smoke alarms.

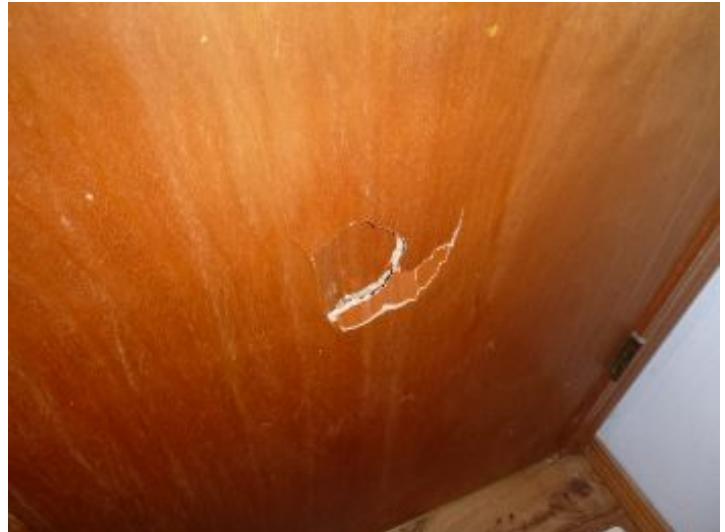
4.1. One or more of the interior doors was damaged (split or holes). Repair or replacement is recommended.

Damage to interior door.

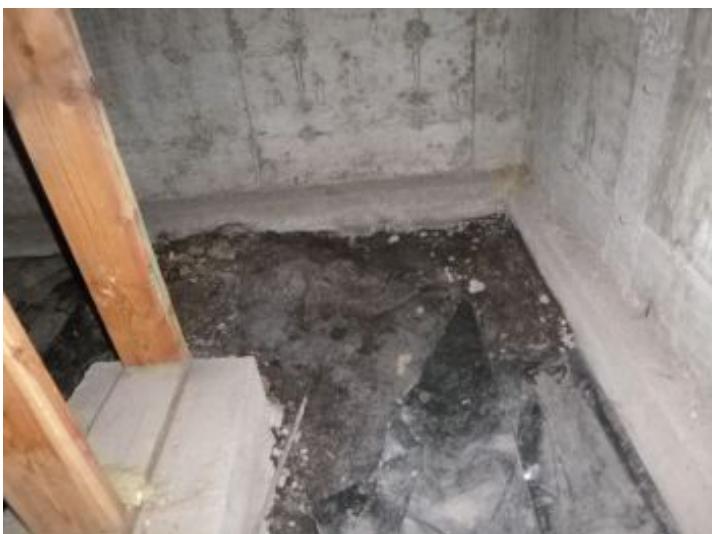
2.1. Dampness was noted at one or more areas in the crawl space.. This can increase the risk of insect infestation, mildew and rot. Recommend locating and correcting the source of the dampness, which may include improving exterior drainage or even the installation of a sump pump.

Damp soil in crawl space.

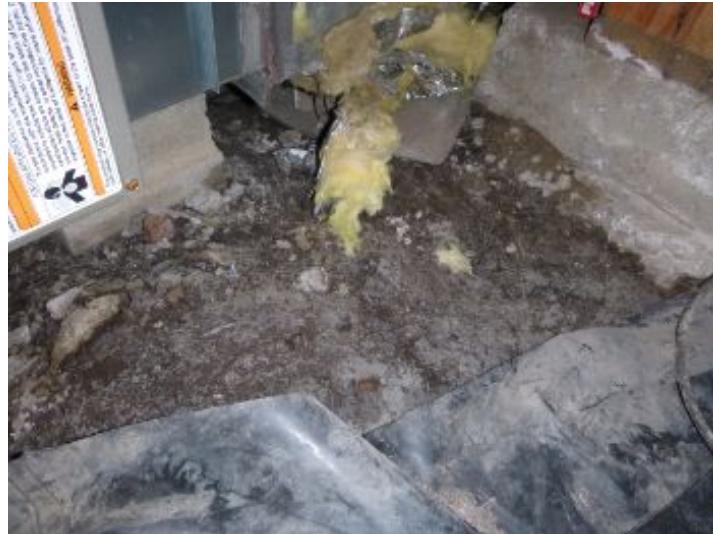
More damp soil in crawl space.
